Biophysical Wetland Values

Appendix 2

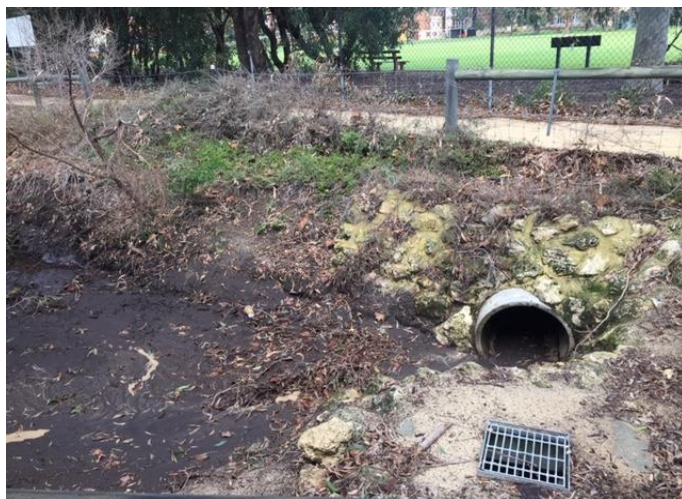
Figure 1 - Nutrient stripping basin at Stirling Road Park

The nutrient stripping basin adjacent to the Stirling Road playground has previously had issues with sediment runoff blocking the drain outlet. The sediment was removed, and the basin was levelled out to prevent further blockages.

- Continue to monitor drain sites for blockages.
- Remove sediment build-up before major blockages.
- Vegetate the Stirling Road nutrient stripping basin with sedges to filter runoff water and enhance the aesthetic amenity of the basin.
